Backgrounder - Hot tub repairs continue

During the annual maintenance shutdown, staff and specialized contractors began complex repairs to the hot tub at the North Peace Leisure Pool.

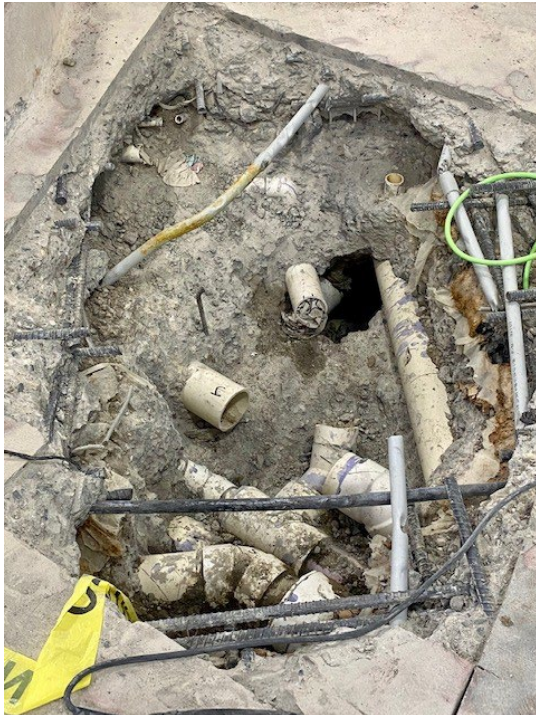
Image 1 (before repairs, broken pipes removed)

- Used sonar technology for leak detection and broken pipes
- Removed finishing from the hot tub (see image 3)
- Opened several areas inside the hot tub to make repairs to two main drains and two jets
- Opened the pool deck to repair leaks identified through sonar scanning (see images 1 and 2)
- Repaired the concrete (see image 3)
- Refinished the hot tub (see image 4)
- Filled and tested the hot tub
- Used camera equipment to search for additional piping breaks
- Plugged or bypassed piping around some additional leaks
- Utilized a product to seal minor cracks in the system
- Restarted the investigation process again, isolating parts of the systems
- Identified a leaking valve that needs replacement before additional investigation work can continue
- Found and repaired an additional leak in the hot tub basin

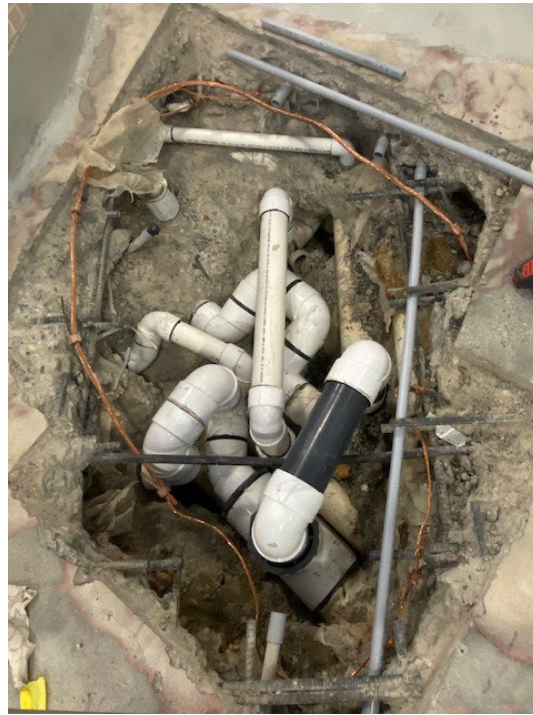
Image 2 (after repairs)

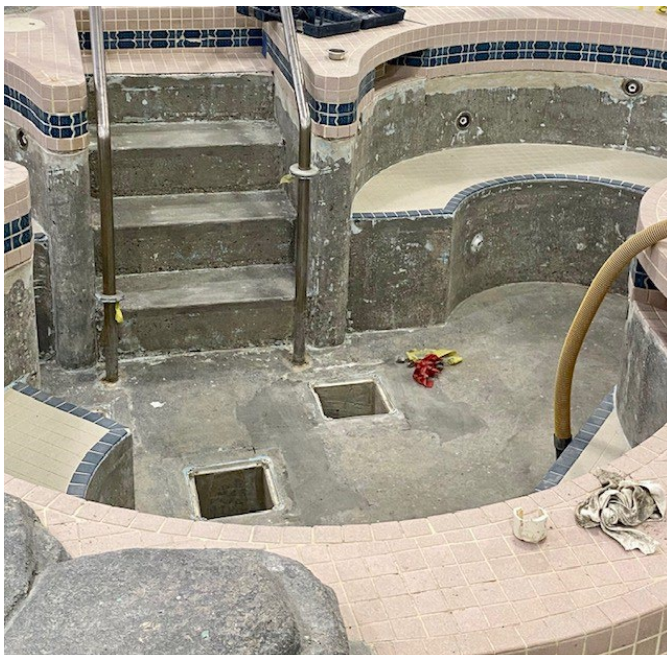
Image 3 (finishing removed)

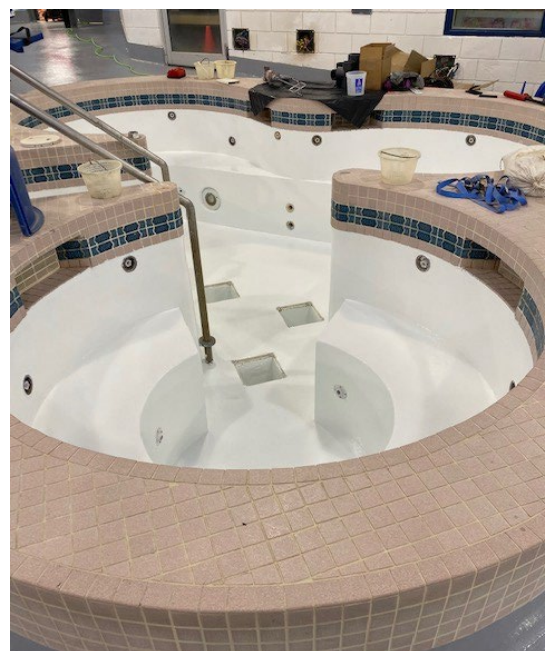
Image 4 (after repairs)
